# Status Report

## 100 keV DC Gun Test Stand

September 2, 2005

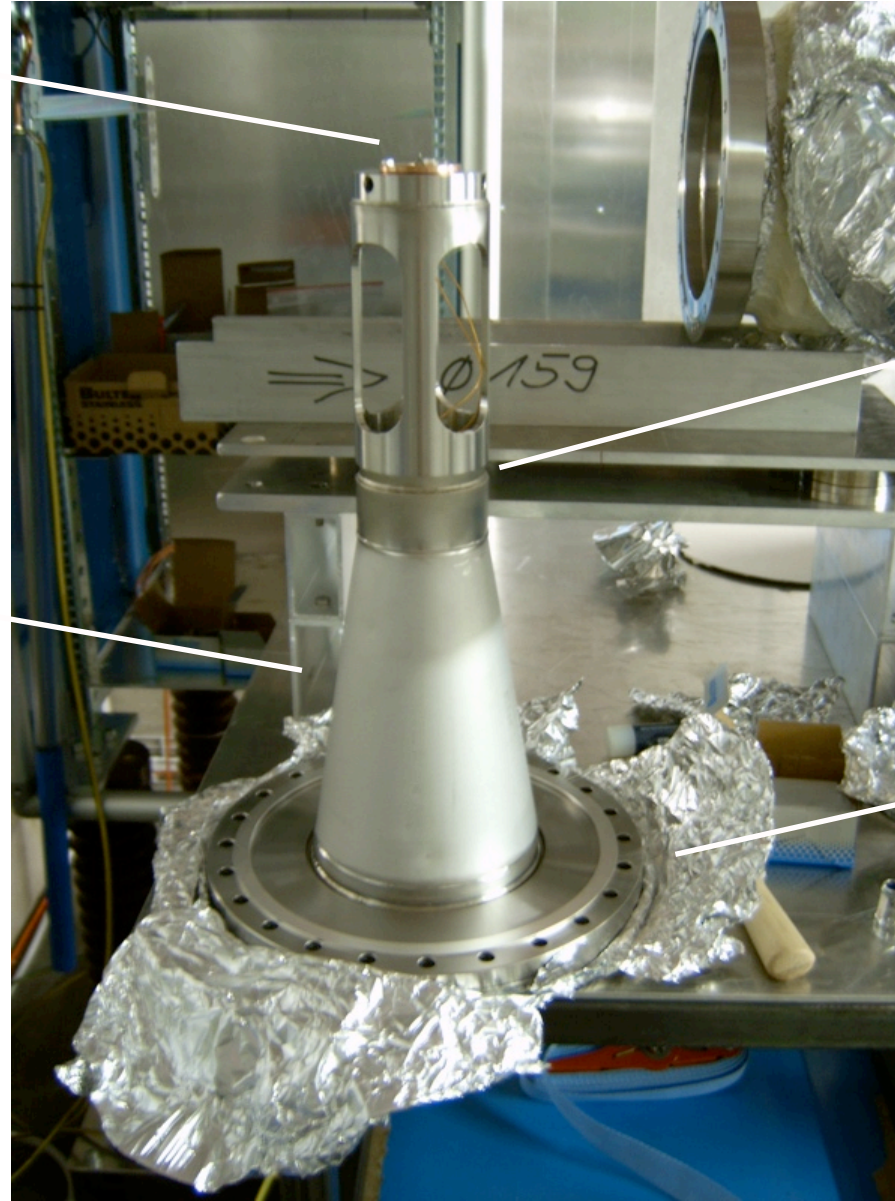
# Current Cathode Cone Design

Cathode  
mount

Cone

Custom  
welded  
feedthroughs

CF200 flange

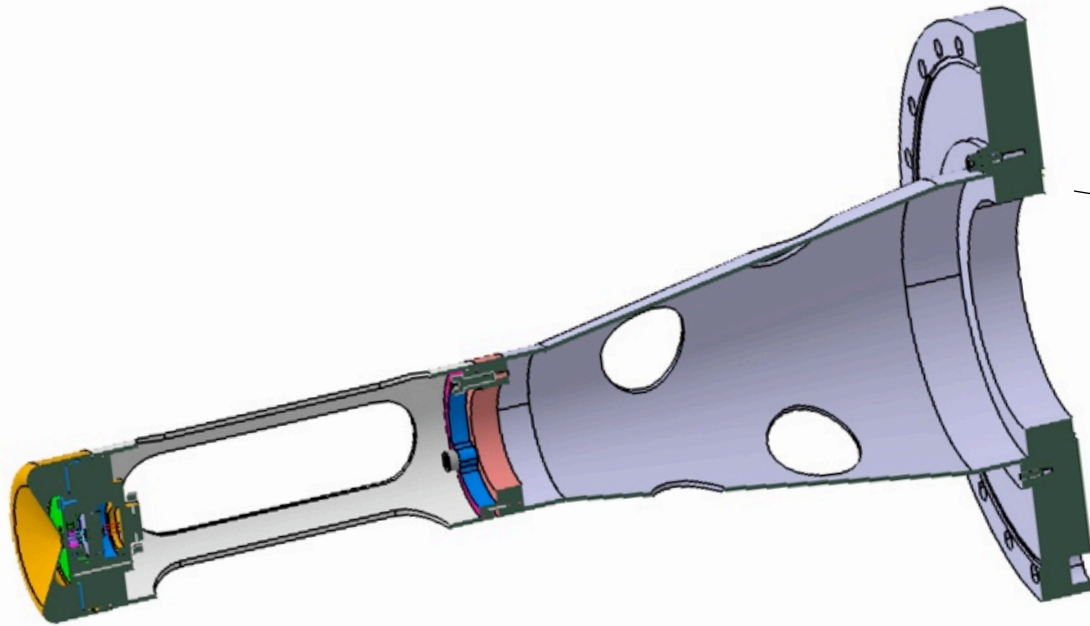
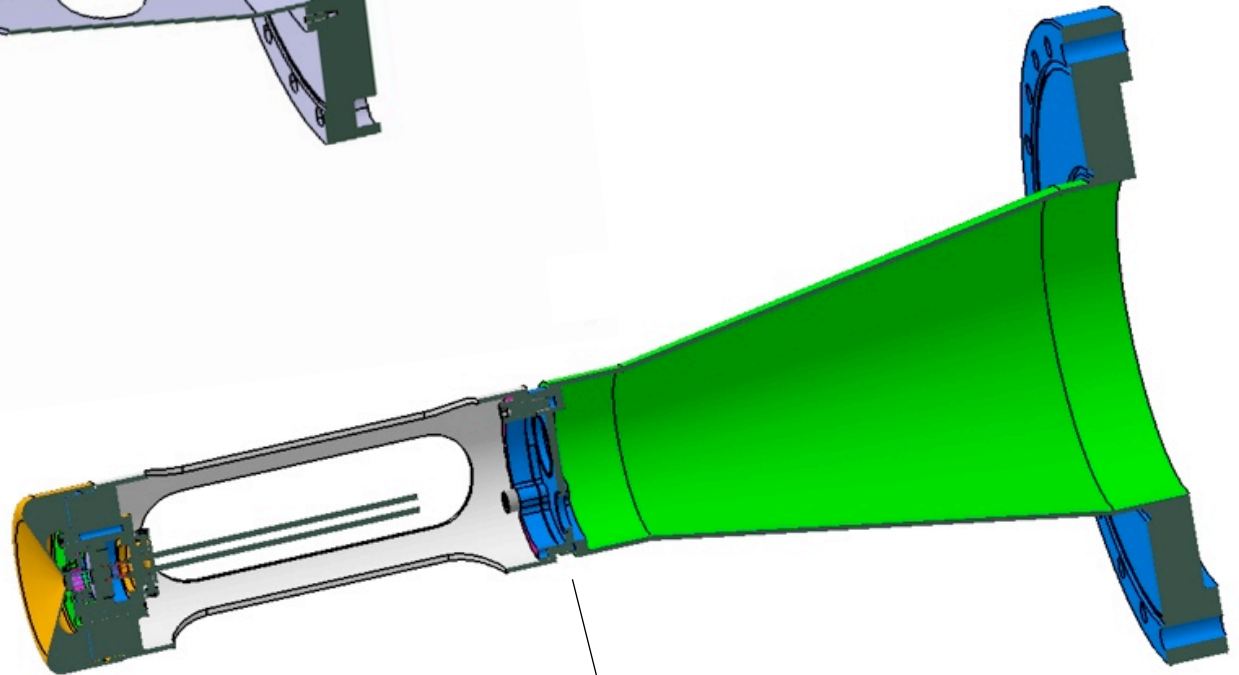
# New vs. Old Cathode Cone Design

CFI100 flange for mounting  
standard CFI 6/40 feedthroughs

Custom welded  
feedthroughs

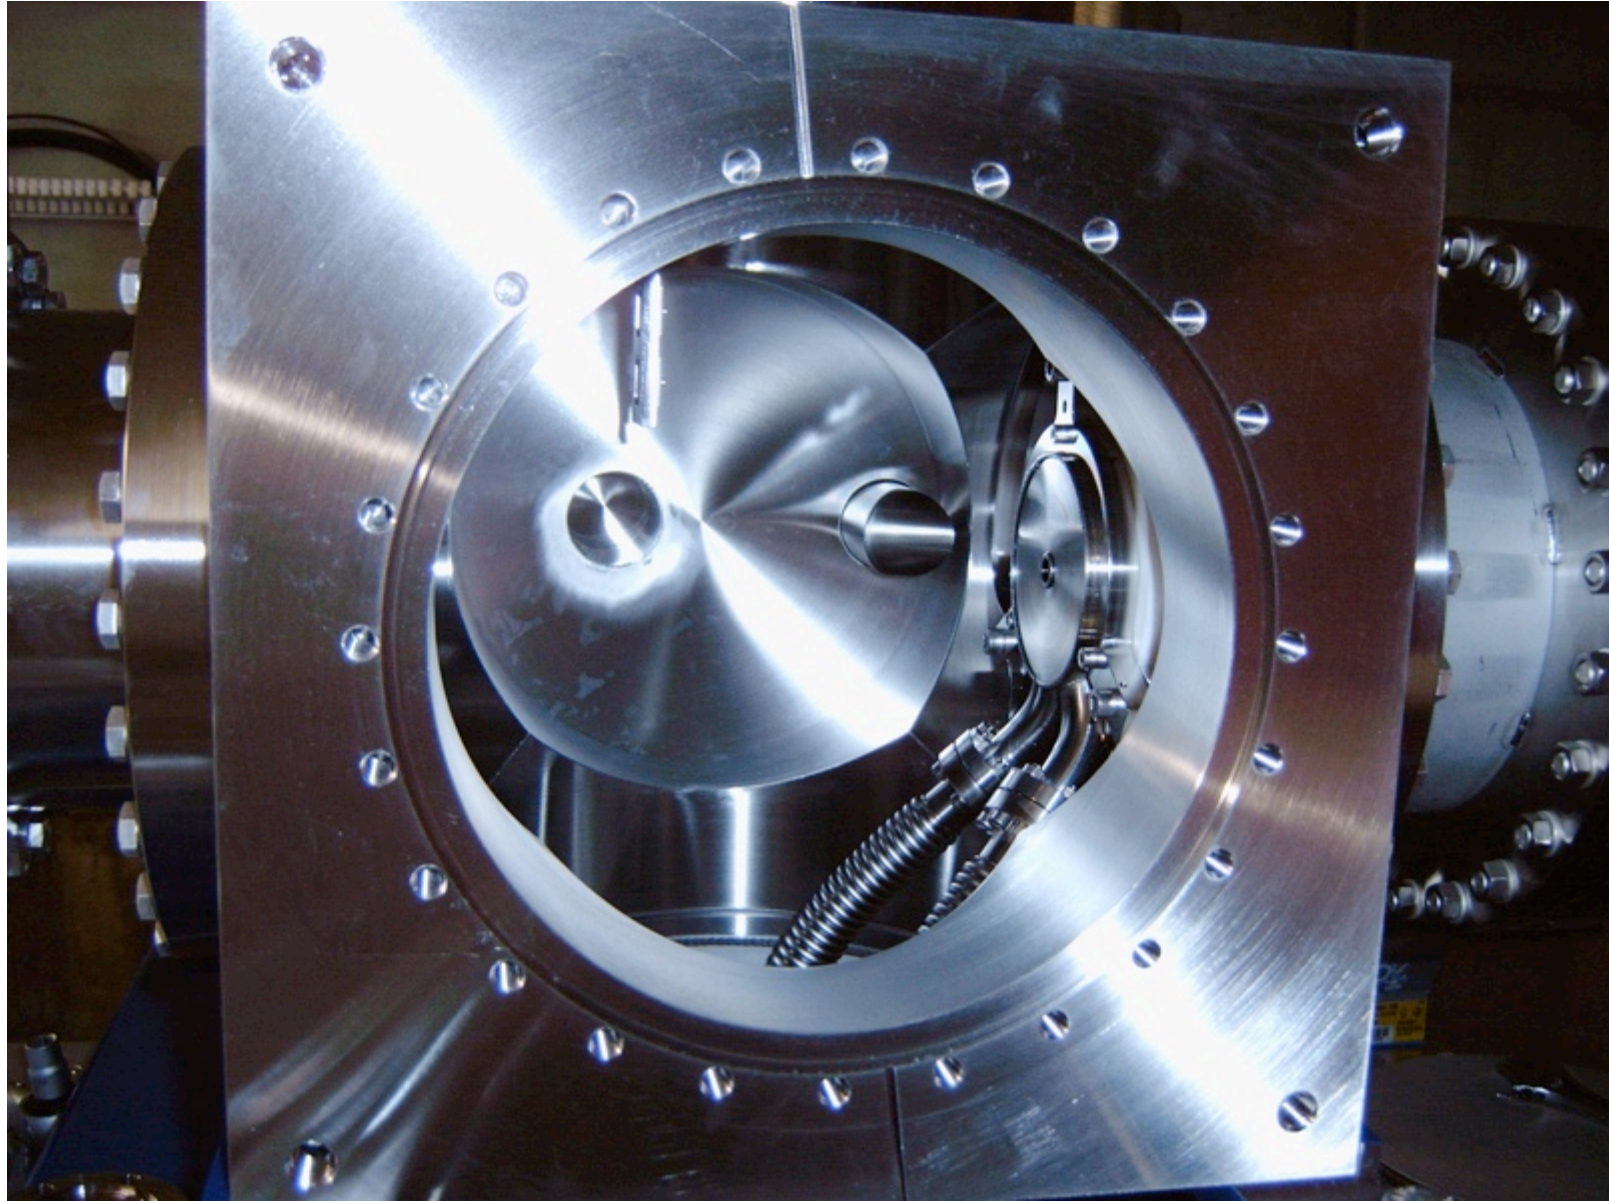
# Solenoid with Faraday Cup, YAG Screen and Slit Array
