100 keV DC Gun Test Stand

Intermediate Report: FEA Damage (SRI - 1257E)

December 21, 2005

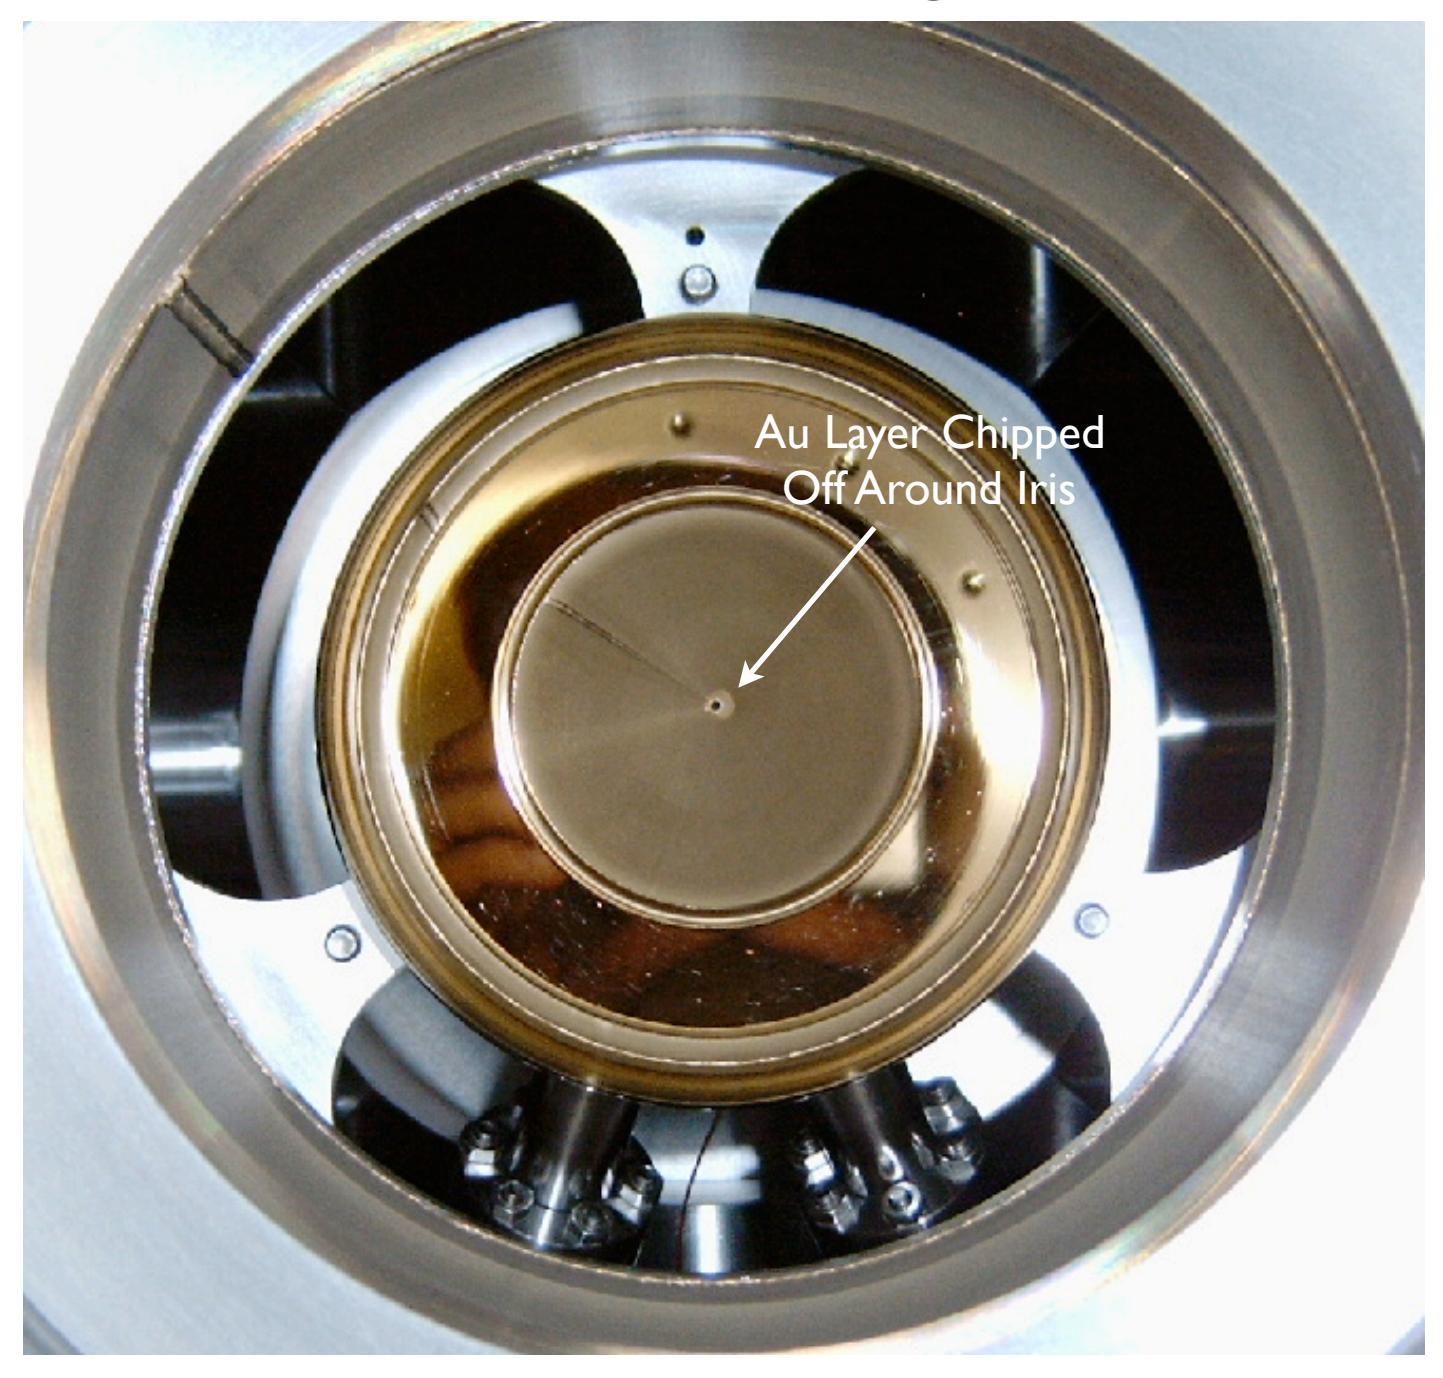
Anode Damage

- After venting chamber observed severe damage
 - Anode: Au plating chipped off asymmetrically around iris
 - FEA: cracks due to excessive thermal load on gate layer, Au sputters on FEA due to back bombardment

- HV arc at 82kV caused first crater on anode iris (peak field strength region)
 → Increased local field enhancement triggering parasitic FE from gate layer
 - \rightarrow High leak currents to anode
 - \rightarrow Increased desorption of Au plating in the vicinity of the crater
 - \rightarrow Increased emission from FEA to damaged area on anode
- Resulting in
 - \rightarrow High thermal load on gate layer leading to cracks
 - \rightarrow Au back bombardment onto FEA leading to shortcut between gate and tips

- Removal of dead FEA and damaged anode electrode
- FEA will be replaced (with no. 2 of 4)
- Replace anode ASAP with non-plated pure Cu anode as in the original design (Au plating was never foreseen by us, but done by the workshop without further inquiry to avoid oxidation of Cu surface which they believed harmful)
- Re-bake chamber, recondition FEA, step up HV slowly, condition carefully
- No HV operation when increased leak current is collected on anode
- No FEA operation in high leak current condition

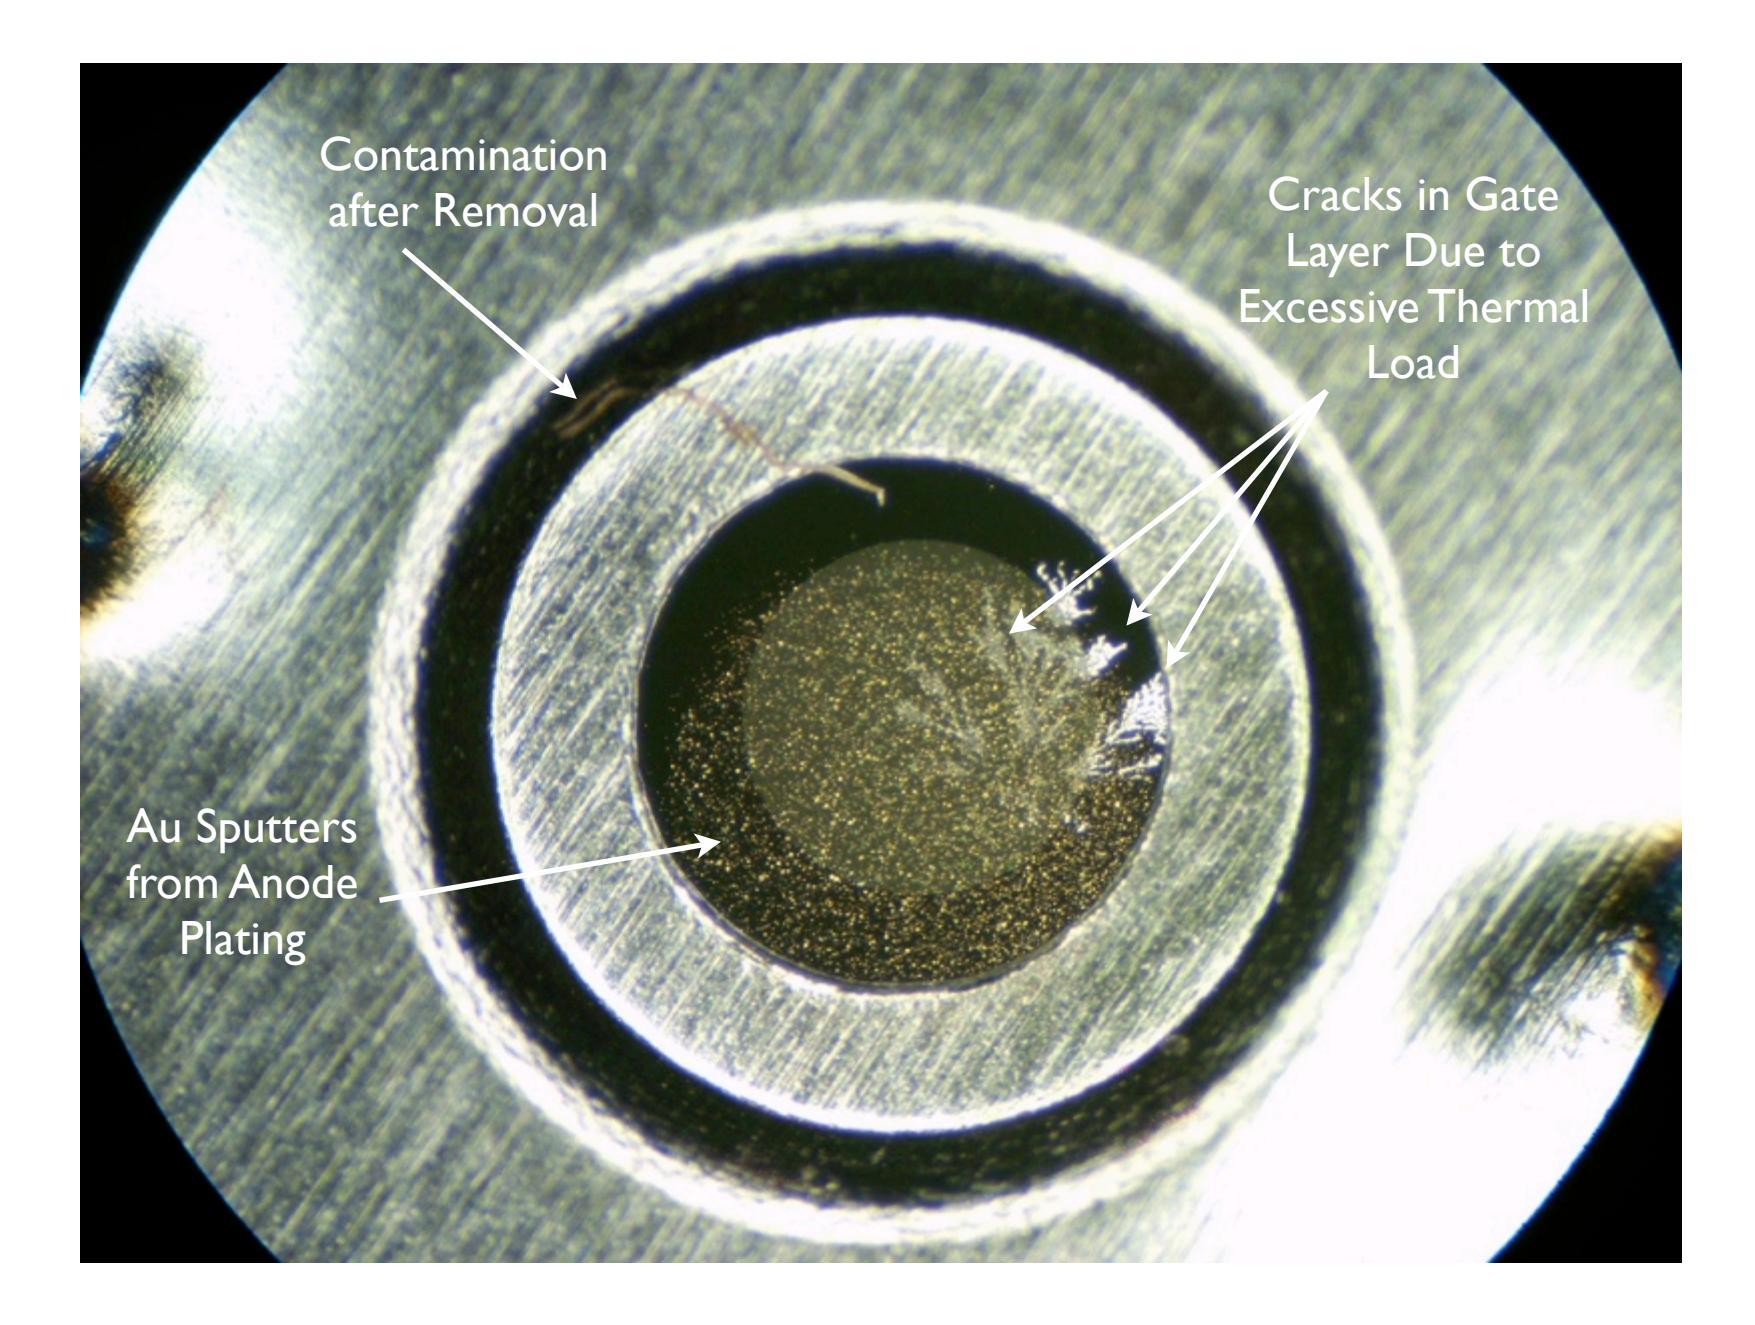
FEA Damage

- After applying gate voltage on FEA with increased leak current levels
 → suddenly zero emission from FEA detected on anode or FC
 → FEA dead; finite ohmic resistance (48kΩ) between gate and tips
